# FACILITIES ASSESSMENT

CABRILLO UNIFIED SCHOOL DISTRICT  
ADDENDUM, NOVEMBER 13, 2020

# HALF MOON BAY HIGH SCHOOL

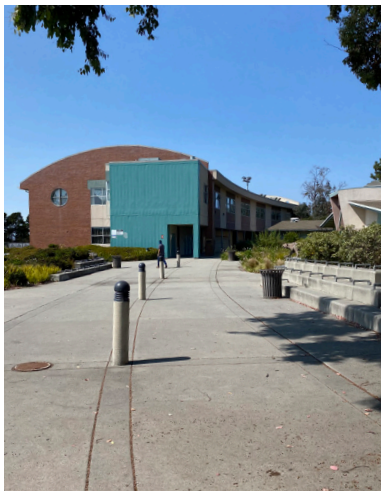
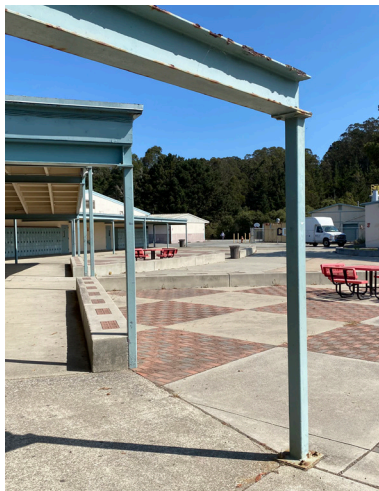
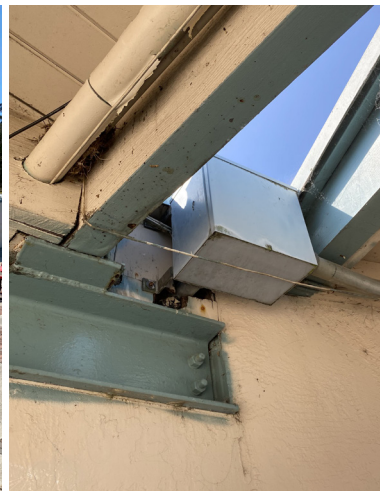
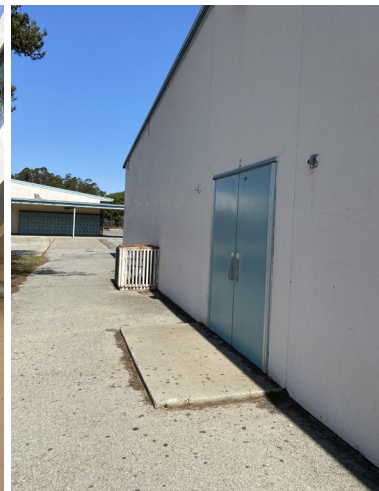
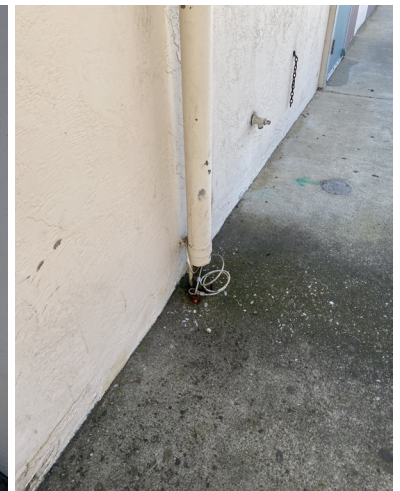
- Numerous door thresholds are not compliant with current Accessibility codes
- Multiple pathways through campus are not code compliant
- Accessible parking spots are not code compliant
- Stair/ramp railings are not code compliant at 7 locations
- Ramps are not code compliant
- Accessible student drop off is not code compliant
- All exterior exposed metal has rust damage due to the coastal climate
- Covered walkway has dry rot damage in multiple locations

The Half Moon Bay High School site has significant accessibility issues. Also, due to its coastal location, exterior metal has significant rust damage & portions of the covered walkway have dry rot.

- Replace concrete pads & thresholds to make all doors code compliant
- Upgrade pathways to be compliant with current Accessibility codes
- Provide required number of code compliant parking spots
- Replace railings at stairs
- Replace non compliant ramps with code compliant ramps
- Provide code compliant student drop off
- Repair/replace rusted metal
- Repair/replace areas of dry rot

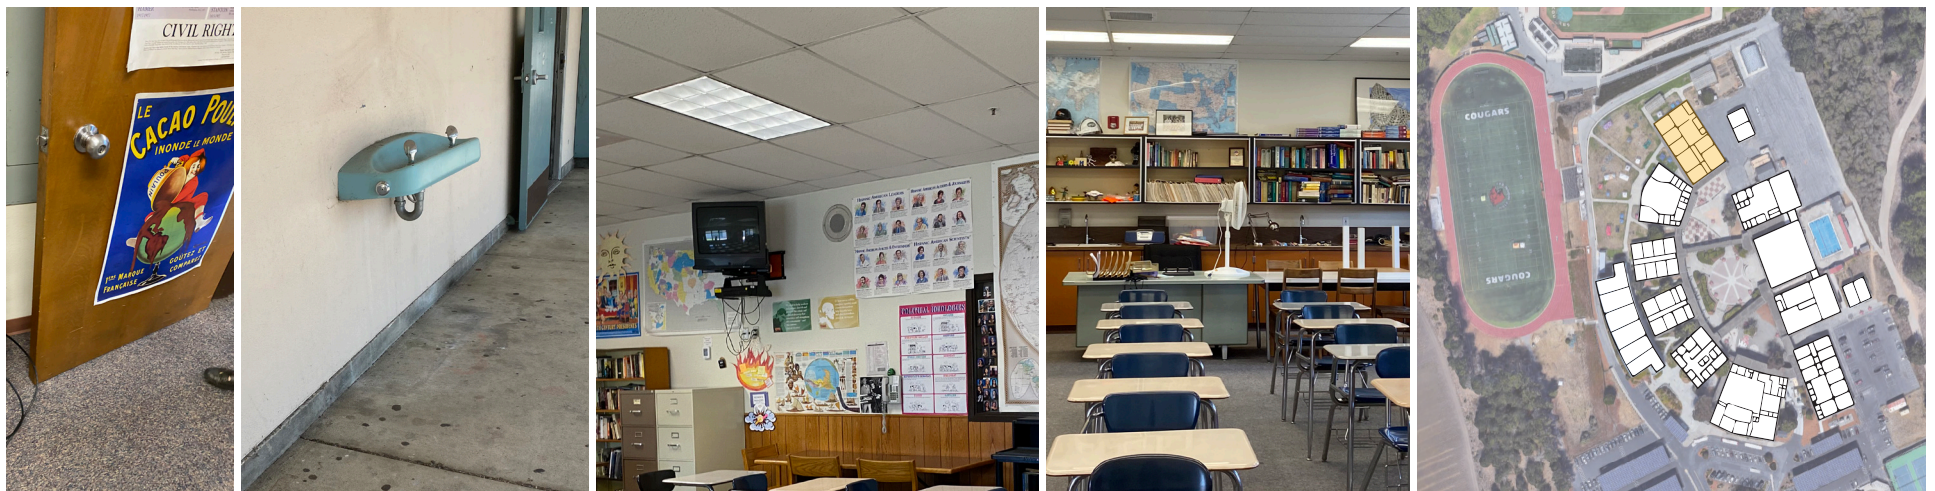
- Doors into teacher prep rooms lack accessible hardware
- Drinking fountain is not accessible
- A/V equipment includes unused wall-mounted televisions
- Mechanical units & accessories are outdated
- Carpet has reached the end of its useful life
- Ceiling has sprinklers & ceiling grid is in fair condition
- Interior finishes, aside from the carpet, are in fair condition
- Upper cabinets lack doors, & rooms lack an accessible sink
- Storage is insufficient for current needs

- Replace non-compliant door hardware with code compliant hardware
- Replace drinking fountains with accessible drinking fountains
- Remove unused A/V equipment
- Replace carpet throughout
- Replace and reinsulate the auxiliary heating unit, heating coils, valves, hot water piping and exhaust fans.
- Replace casework and include accessible sink

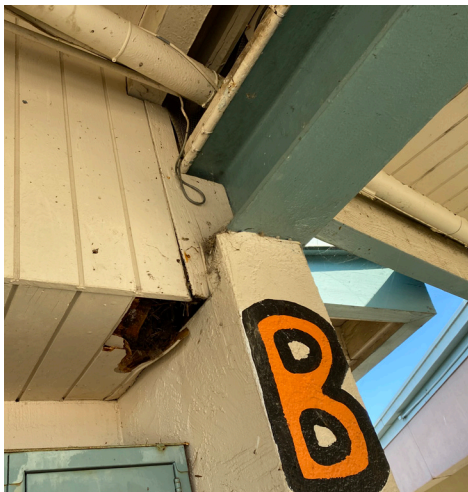
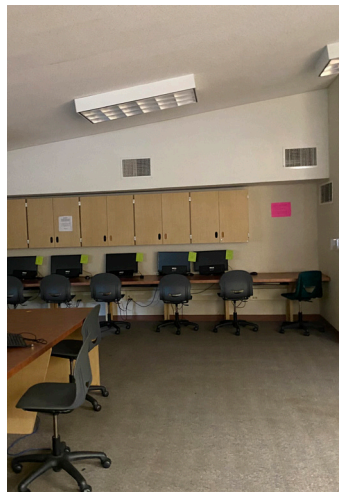
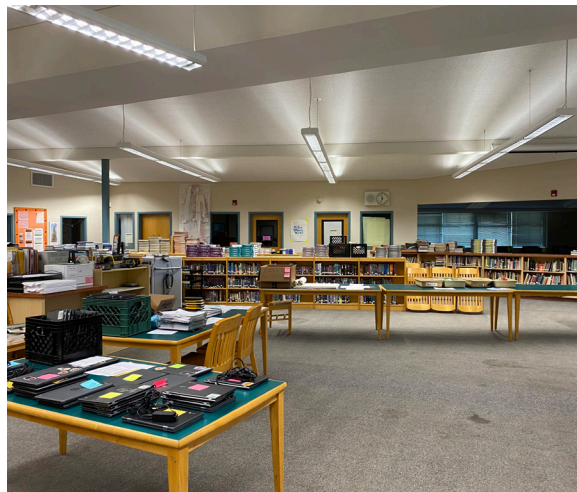
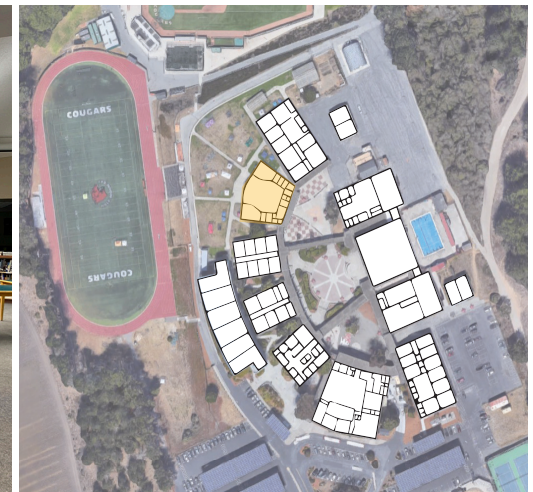
- Mechanical units & accessories are outdated
- Restrooms lack exhaust ventilation system
- The operable area of the windows do not meet current Title 24 ventilation requirements
- Lights have been retrofitted recently with LEDs
- Adhesive-applied ceiling tiles are in good condition
- Window coverings have reached the end of their useful life
- Casework is somewhat dated, but in fair condition
- Exterior shows significant dry rot damage at exterior walkway roof
- Carpet has reached the end of its useful life
- Drinking fountain appears to be code compliant

Building B is located towards the north end of the Half Moon Bay High School campus. It directly faces the central quad. It houses the school library and 2 computer labs. Building B needs exterior repairs, mechanical upgrades, & minor finish upgrades

- Replace and reinsulate the air handling unit, heating coils, valves, hot water piping and exhaust fans.
- Install rooftop exhaust fans for both restrooms
- Replace radiant heaters in classrooms with classroom type unit ventilators
- Repair/replace areas of dry rot
- Replace window coverings
- Replace carpet

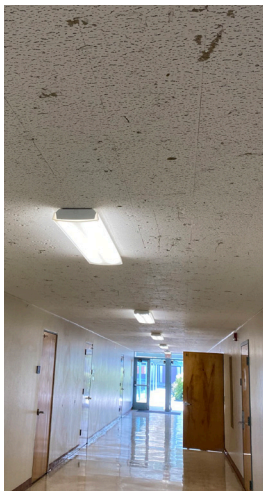
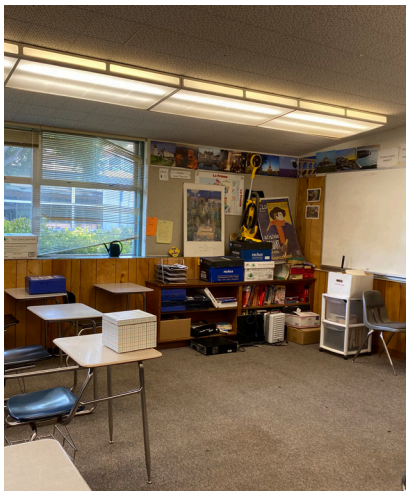
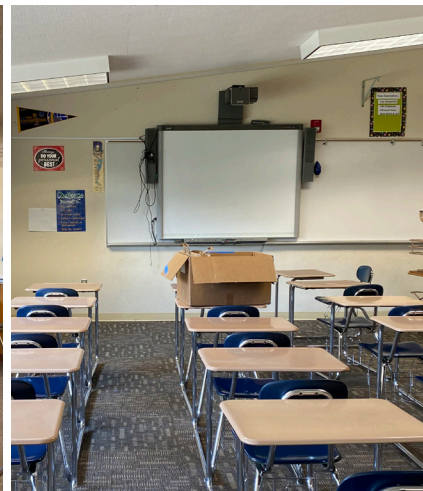
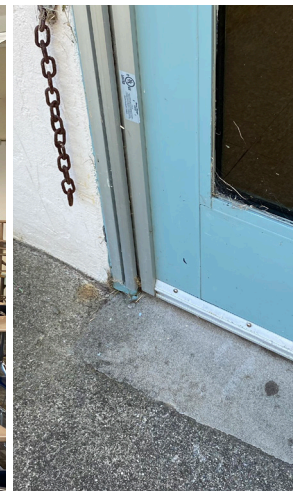
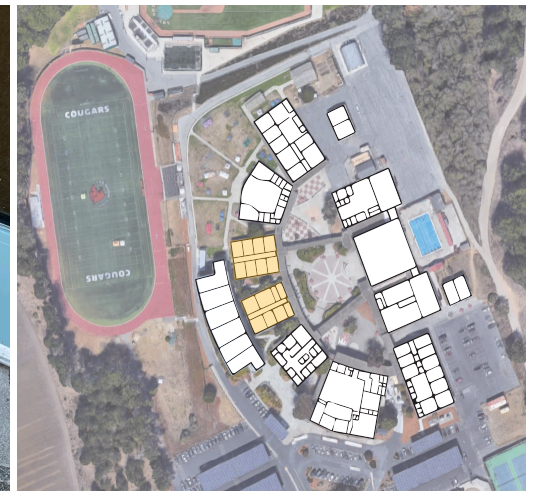
- Exterior door thresholds do not meet current ADA code
- Many classrooms have 1 electrical outlet
- The operable area of the classroom windows does not meet current Title 24 ventilation requirements
- Mechanical units & accessories are outdated
- Select classrooms have been renovated with updated carpet and LED light fixtures
- Adhesive-applied ceiling in hallways shows extensive damage
- Window coverings have reached the end of their useful life

Buildings C & D are located on the west side of the main quad. Building C consists of 8 classrooms and Building D includes 6 classrooms & 2 restrooms. Both buildings need to be updated to meet current ADA standards. They also require mechanical, electrical, & finish upgrades

- Update door thresholds to meet current ADA standards
- Provide a minimum of 4 electrical outlets per classroom
- Replace hallway ceiling tiles
- Replace radiant heaters in classrooms with classroom type unit ventilators
- Replace and reinsulate the air handling unit, heating coils, valves, hot water piping and exhaust fans
- Update classrooms that have not yet been modernized with new LED lighting and new carpet
- Replace window coverings

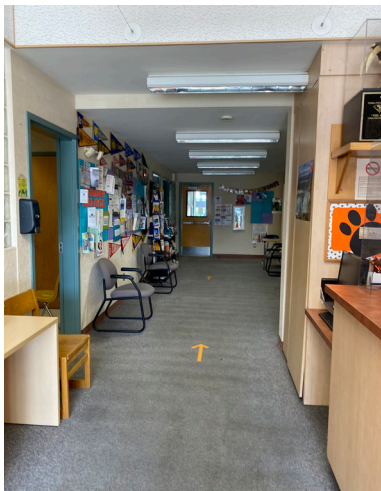
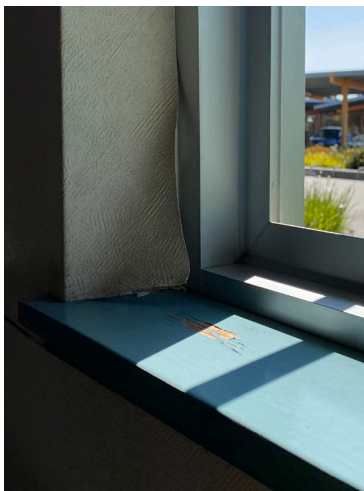
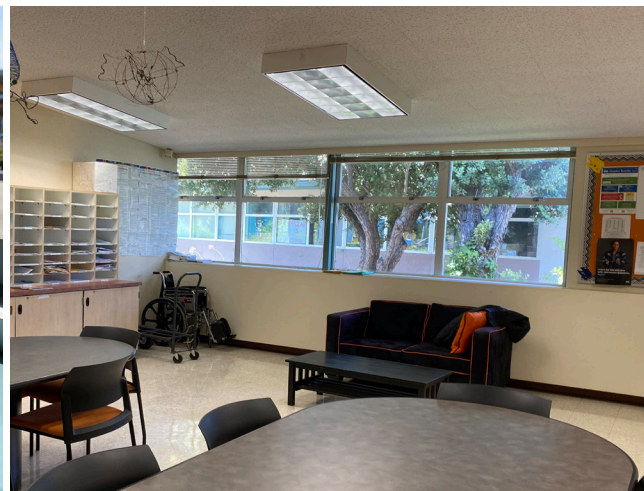
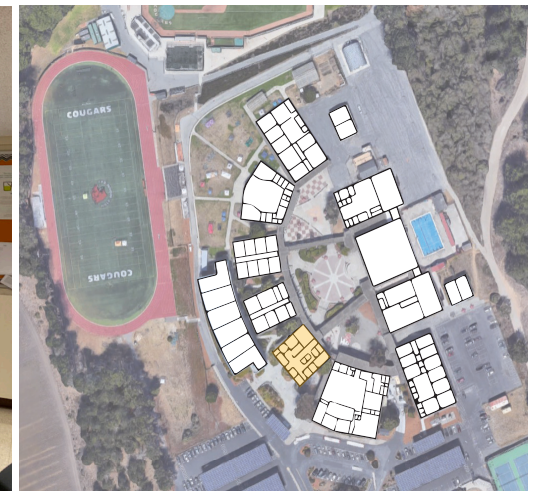
- Mechanical units & accessories are outdated
- Building lacks individual light switches
- The operable area of most windows do not meet current Title 24 ventilation requirements
- Lights have been retrofitted recently with LEDs
- Adhesive-applied ceiling tiles are in fair condition
- Casework is in good condition
- Carpet has reached the end of its useful life
- Interior finishes are in fair condition

Building E, the administration building, is located on the southwest side of the main quad. This building marks the entrance to the school. Building E requires mechanical & finish upgrades

- Replace radiant heaters with classroom type unit ventilators
- Replace and reinsulate the air handling unit, heating coils, valves, hot water piping and exhaust fans
- Replace carpet
- Repair/replace interior finishes

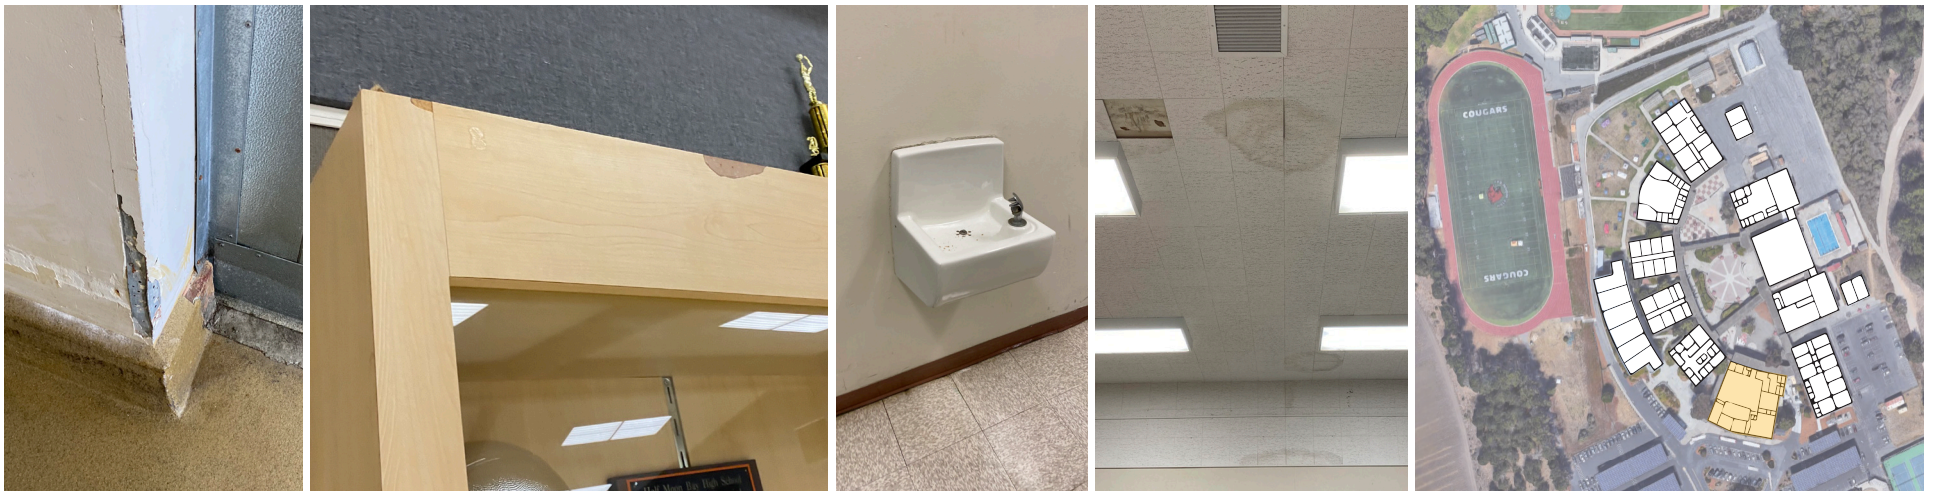
- Interior doors lack accessible hardware
- Drinking fountain is not code compliant
- Mechanical units & accessories are outdated
- The operable area of the windows in the auxiliary classrooms does not meet current Title 24 ventilation requirements
- Hot water piping in mechanical rooms show signs of severe leakage in multiple locations
- Walls & roof in band room have water damage
- Casework in the multipurpose room & chorus room has reached the end of its useful life
- Wall, door & stage surfaces are significantly damaged
- Most of the interior finishes have reached the end of their useful life

Building F is located on the south side of the main quad. This building includes the multipurpose room, the kitchen, the band & chorus rooms, & the staff room. Building F requires accessibility, mechanical, & finish upgrades

- Replace non-compliant door hardware with code compliant hardware
- Replace drinking fountain with accessible drinking fountain
- Replace radiant heaters with classroom type unit ventilators
- Replace and reinsulate the air handling unit, heating coils, valves, hot water piping and exhaust fans
- Replace acoustic tiles in band room
- Replace casework
- Repair/replace interior finishes

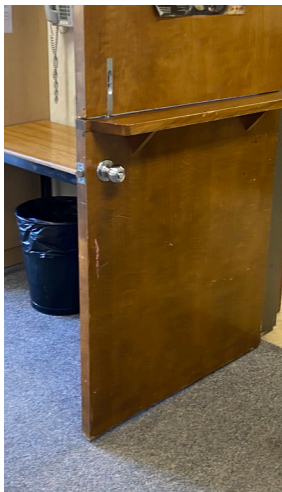
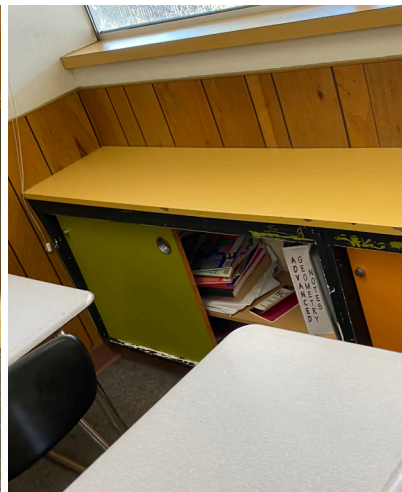
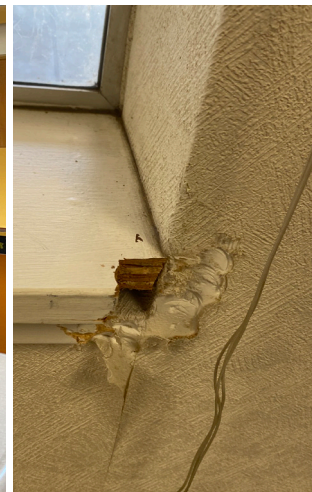
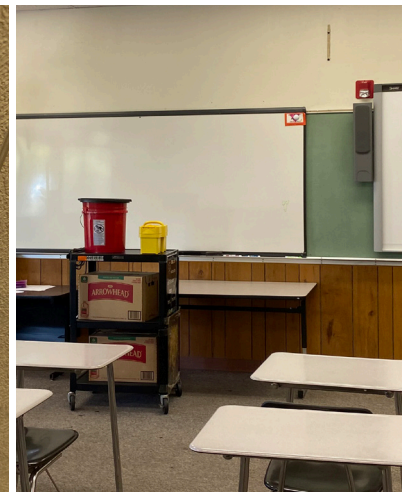
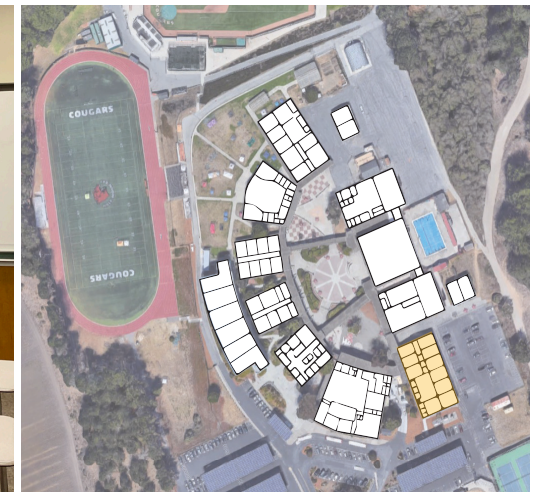
- Mechanical units & accessories are outdated
- Interior doors lack accessible hardware
- Carpet has reached the end of its useful life
- Ceiling has sprinklers & ceiling grid is in fair condition
- Window shades have reached the end of their useful life
- Building lacks signage
- Casework has reached the end of its useful life
- Most of the interior finishes have reached the end of their useful life

Building G is located on the south side of the main quad and holds 10 classrooms. Due to its age, Building G needs accessibility, mechanical, & finish upgrades

- Replace and reinsulate the air handling unit, heating coils, valves, hot water piping and exhaust fans.
- Replace non-compliant door hardware with code compliant hardware
- Replace carpet
- Replace window shades
- Add building signage
- Replace casework
- Repair/replace interior finishes

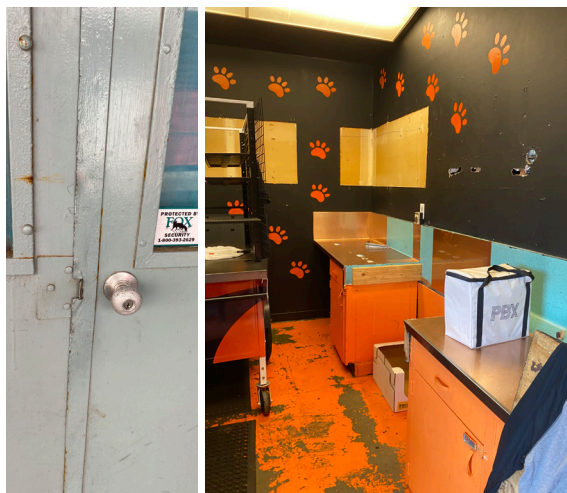
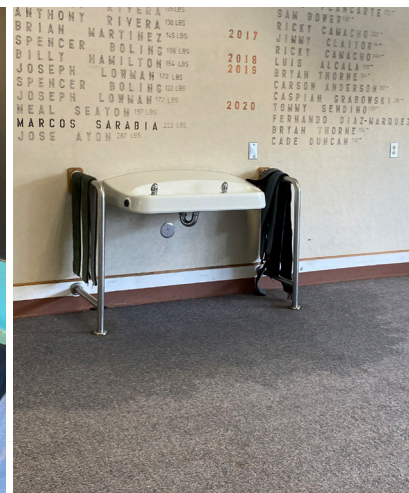
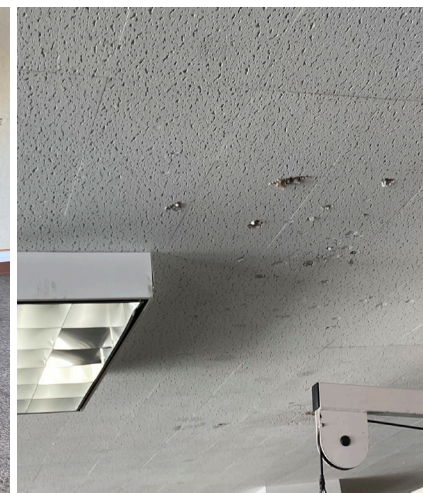
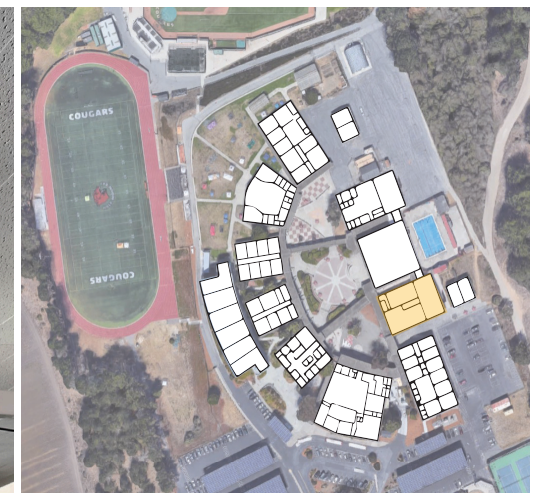
- Doors lack accessible hardware
- Drinking fountains are not ADA compliant
- The operable area of the windows in the some rooms do not meet current Title 24 ventilation requirements
- Exhaust fans in the restroom and girls locker room have reached the end of their useful lives
- Ceilings & walls in weight room & mat room show extensive damage
- Mechanical units & accessories are outdated
- Carpet in mat room has reached the end of its useful life
- All finishes in the student store have reached the end of their useful life

- Replace non-compliant door hardware with code compliant hardware
- Replace at least 1 drinking fountain with an accessible drinking fountain
- Replace and reinsulate the air handling unit, heating coils, valves, hot water piping, exhaust fans, & duct insulation
- Replace exhaust fans at the restroom and girls' locker room
- Replace/repair ceilings & walls at weight room & mat room
- Replace carpet in mat room, & all student store finishes
- Replace radiant heaters with classroom type unit ventilators

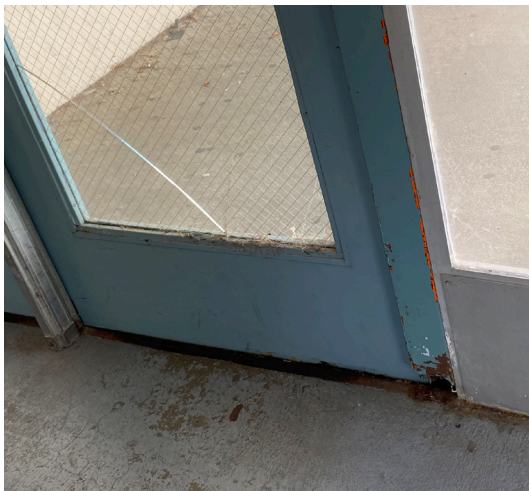
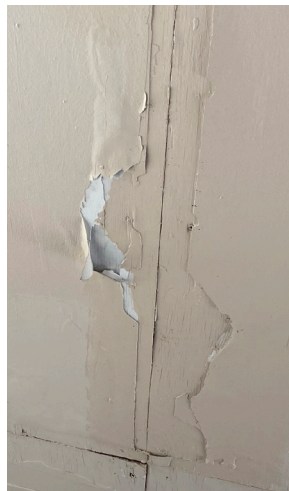
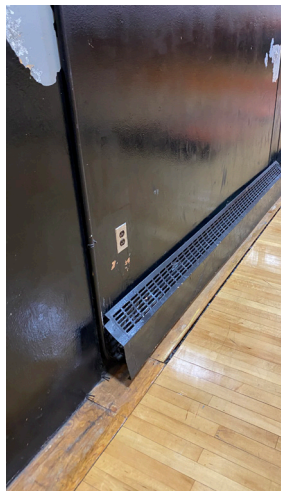
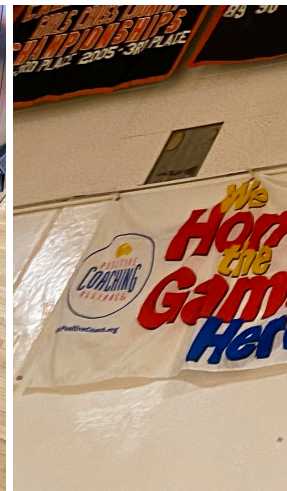
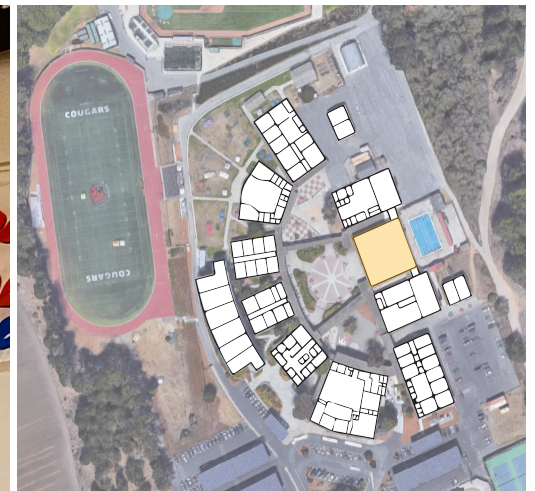
- All mechanical equipment has reached the end of its useful life
- Main wood floor is in excellent condition
- Wood floor perimeter plywood is in poor condition
- Some adhesive-applied ceiling & wall tiles are missing
- Breezeway ceiling has extensive damage
- Breezeway doors have broken glass & extensive rust damage

Building I, the gymnasium, is located on the east side of campus directly across the main quad from buildings C & D. Its connected to buildings H & J by breezeways. Building I needs mechanical & finish upgrades

- Replace all mechanical equipment
- Replace wood floor at perimeter
- Repair/replace damaged or missing adhesive-applied ceiling & wall tiles
- Repair breezeway ceiling
- Replace exterior doors at breezeway

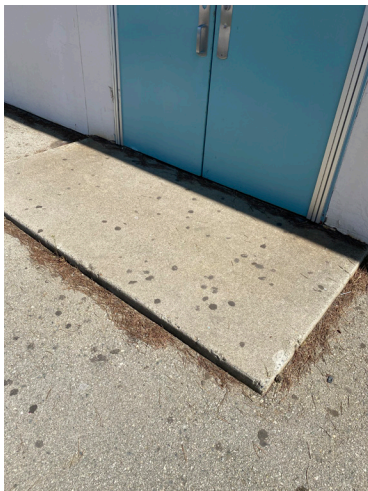
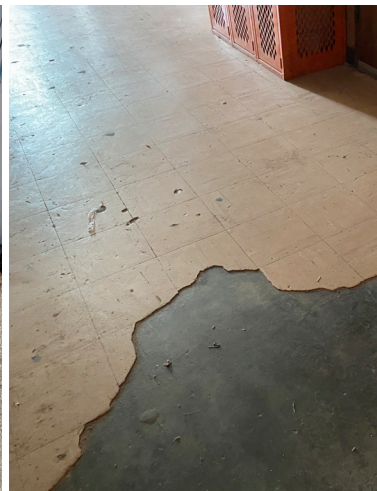
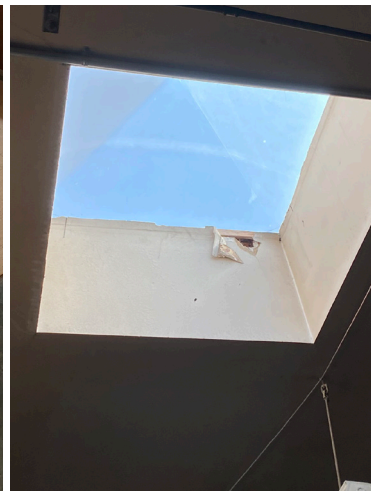
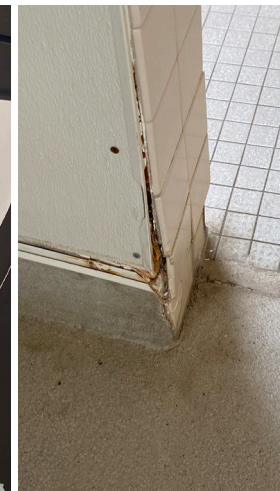
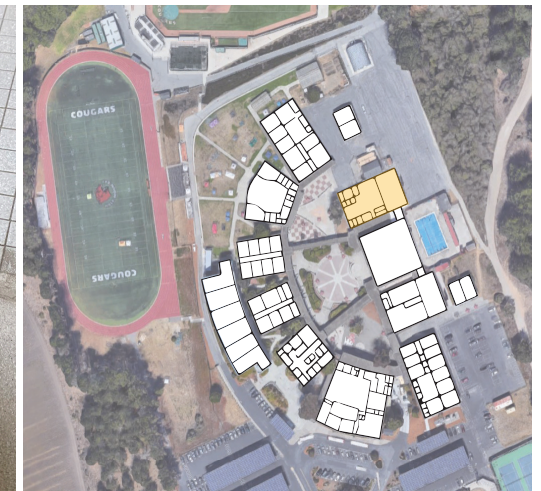
- Building lacks accessible hardware, entrances & fixtures
- Shop floor consists of asbestos tile over concrete
- Mechanical units & accessories are outdated
- Ceiling around skylights shows water damage
- Shower walls in boys' locker room are damaged
- Finishes in boys' locker room have been patched multiple times

Building J is located on the north side of campus and a breezeway connects Building J to the Gym. Building J includes the shop and boys' locker room. Building J needs significant accessibility, mechanical, & finish upgrades

- Replace non-compliant door hardware with code compliant hardware
- Replace concrete pads & thresholds to make all doors code compliant
- Remove asbestos floor tile
- Replace and reinsulate the air handling unit, valves, & hot water piping
- Replace exhaust fans in restroom & boys' locker room
- Provide an accessible sink & drinking fountain at the shop & boys' locker room
- Provide an accessible urinal & toilet at boys' locker room
- Replace wall finishes in boys' locker room
- Repair & reseal skylights

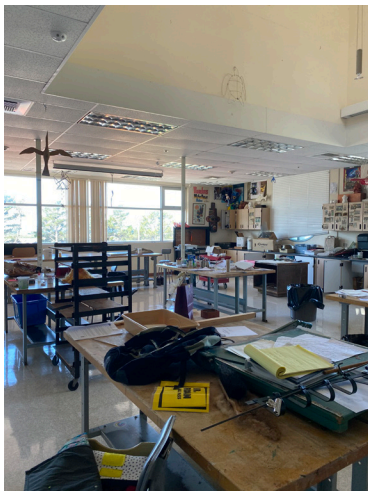
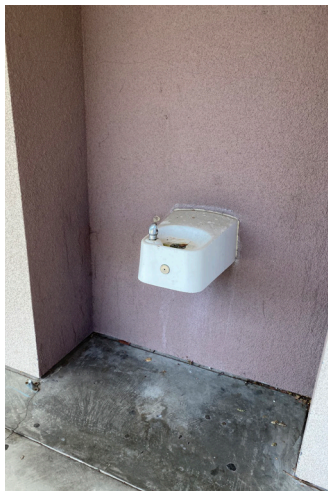
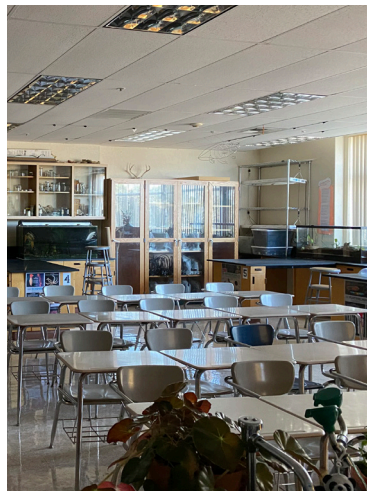
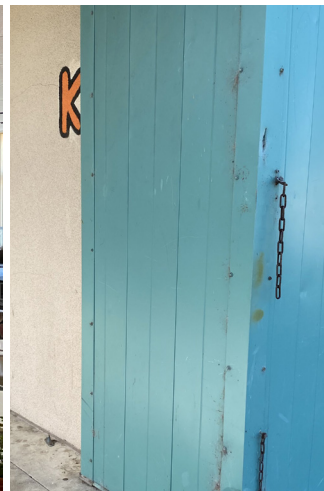
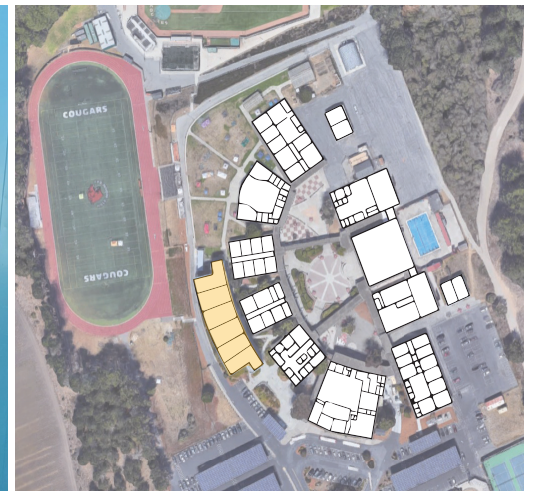
- Hollow metal windows are rusted
- Areas around hollow metal windows have water damage
- Multiple classrooms lack an accessible sink
- Outside drinking fountain is not code compliant
- AC units, associated thermostat & exhaust fans are outdated
- Exterior exposed metal has significant rust damage
- Interior finishes are in fair condition

Building K is located on the west side of campus and is the only two-story building on campus. Building K holds 12 classrooms including the science & art classrooms. Building K needs accessibility, mechanical, & finish upgrades.

- Replace hollow metal windows and repair water damage
- Provide 1 accessible sink per classroom
- Replace exterior drinking fountain with accessible drinking fountain
- Replace AC units, associated thermostat & exhaust fans
- Repair/replace exterior exposed metal

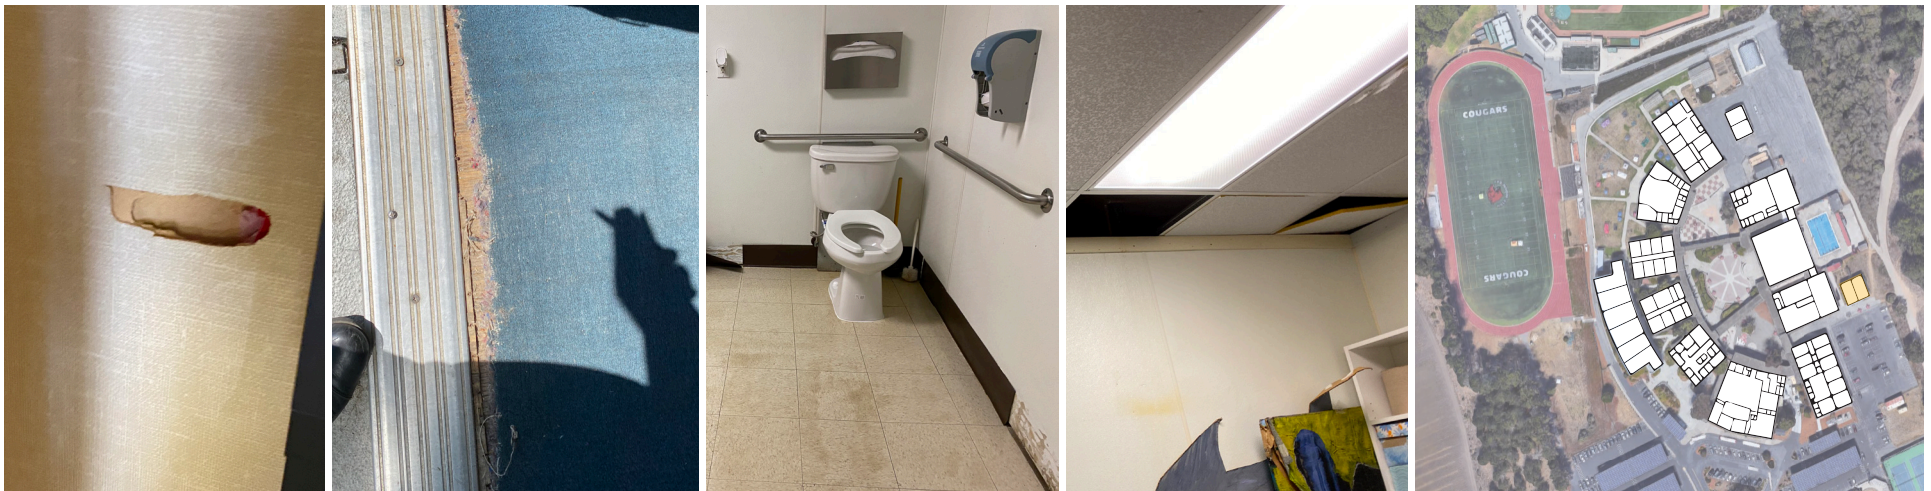
- Carpet has reached the end of its useful life
- Wall base has reached the end of its useful life
- Wall surface is damaged
- Multiple ceiling tiles are missing or damaged
- Lights have not been upgraded to LEDs

Building P consists of 2 portables located at the east side of campus. Each portable houses a single classroom with attached bathroom. Both portables require finish upgrades.

- Replace interior finishes
- Repair wall surfaces where necessary
- Replace damaged or missing ceiling tiles
- Upgrade lights to LEDs
