# FACILITIES ASSESSMENT

CABRILLO UNIFIED SCHOOL DISTRICT  
ADDENDUM, NOVEMBER 13, 2020

# HALF MOON BAY HIGH SCHOOL

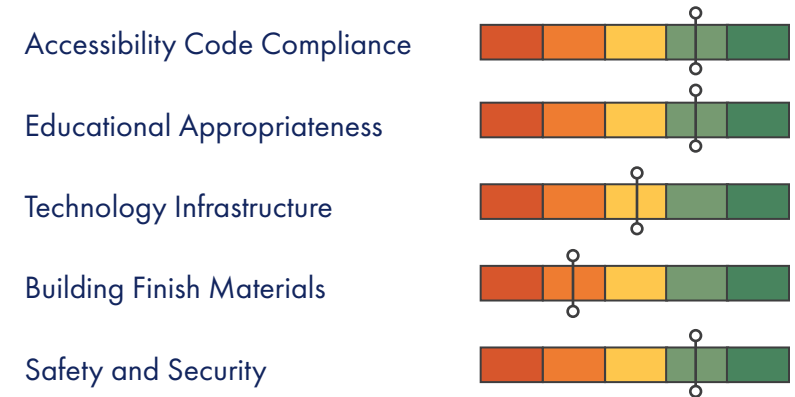
Building B is located towards the north end of the Half Moon Bay High School campus. It directly faces the central quad. It houses the school library and 2 computer labs. Building B needs exterior repairs, mechanical upgrades, & minor finish upgrades

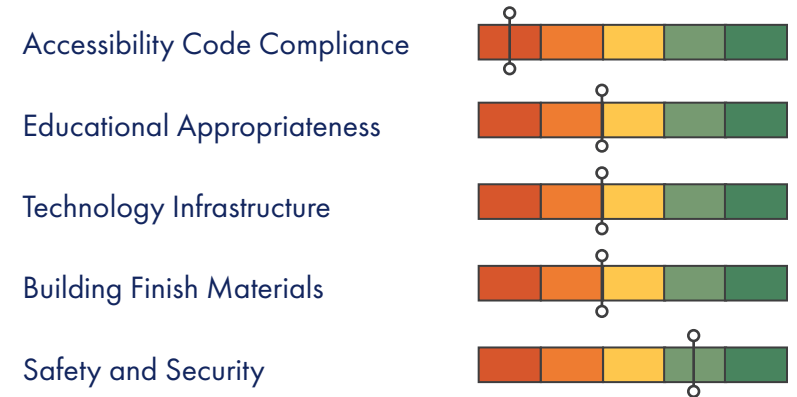
# HALF MOON BAY HIGH SCHOOL BUILDINGS C & D

Buildings C & D are located on the west side of the main quad. Building C consists of 8 classrooms and Building D includes 6 classrooms & 2 restrooms. Both buildings need to be updated to meet current ADA standards. They also require mechanical, electrical, & finish upgrades

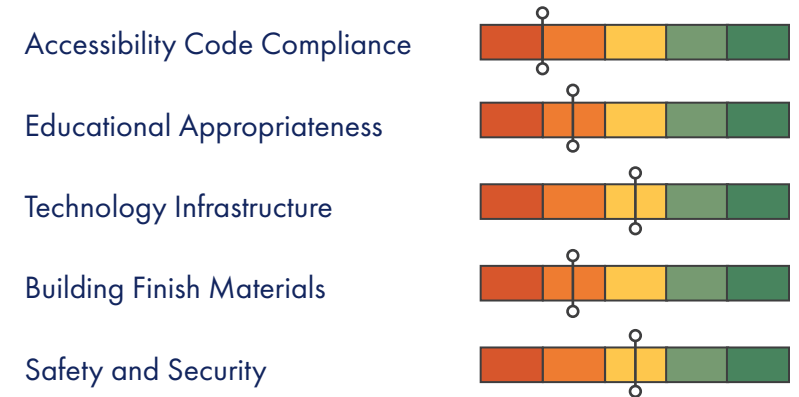
Building F is located on the south side of the main quad. This building includes the multipurpose room, the kitchen, the band & chorus rooms, & the staff room. Building F requires accessibility, mechanical, & finish upgrades

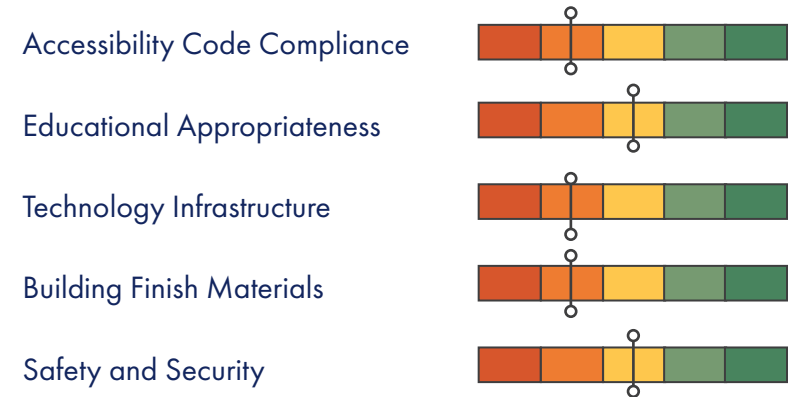
# HALF MOON BAY HIGH SCHOOL BUILDING G

Building G is located on the south side of the main quad and holds 10 classrooms. Due to its age, Building G needs accessibility, mechanical, & finish upgrades
